Navajo Abandoned Uranium Mine

Site Screen Report

Mine Name: South Sunlight
Mine ID: 702

April 2012

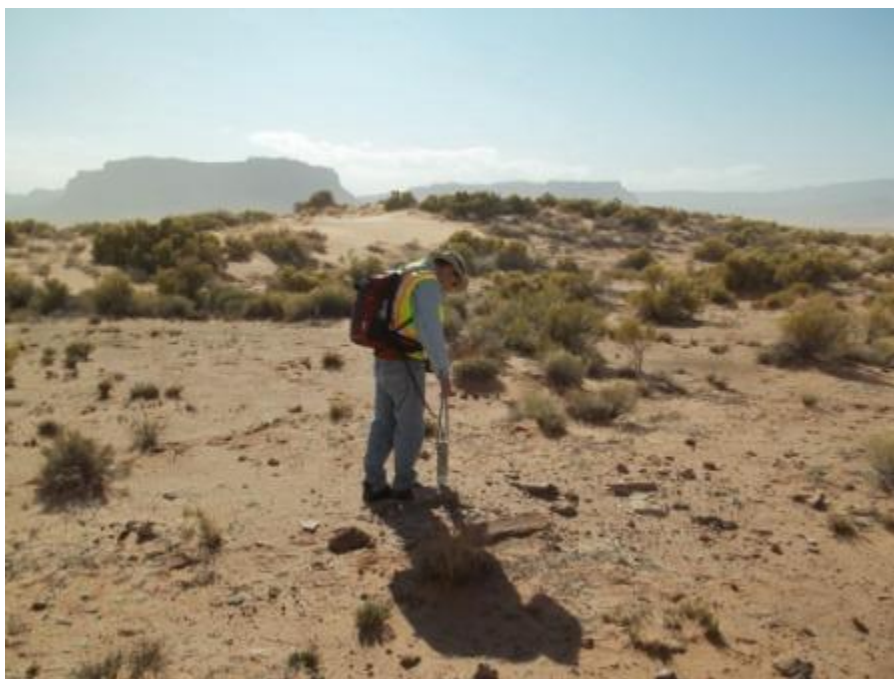
Photo 3

Mine Site #702 – Waste Rock

Waste piles located in center near where old road

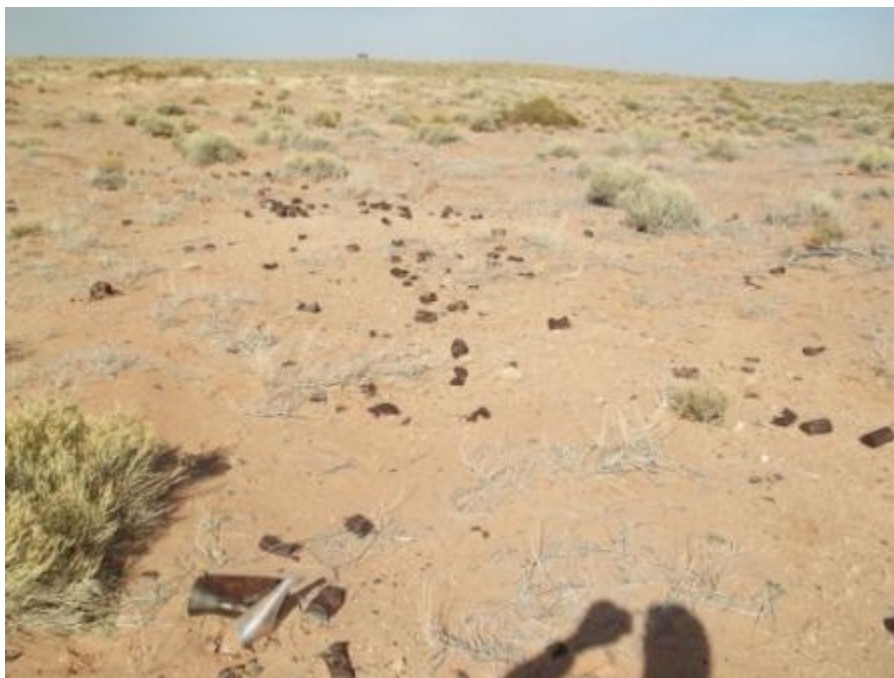
Photo 4

Mine Site #702 – Mining debris

Mining camp waste (cans, bottles with a few waste piles and debris) found in central area near the road and in southwest corner of the site

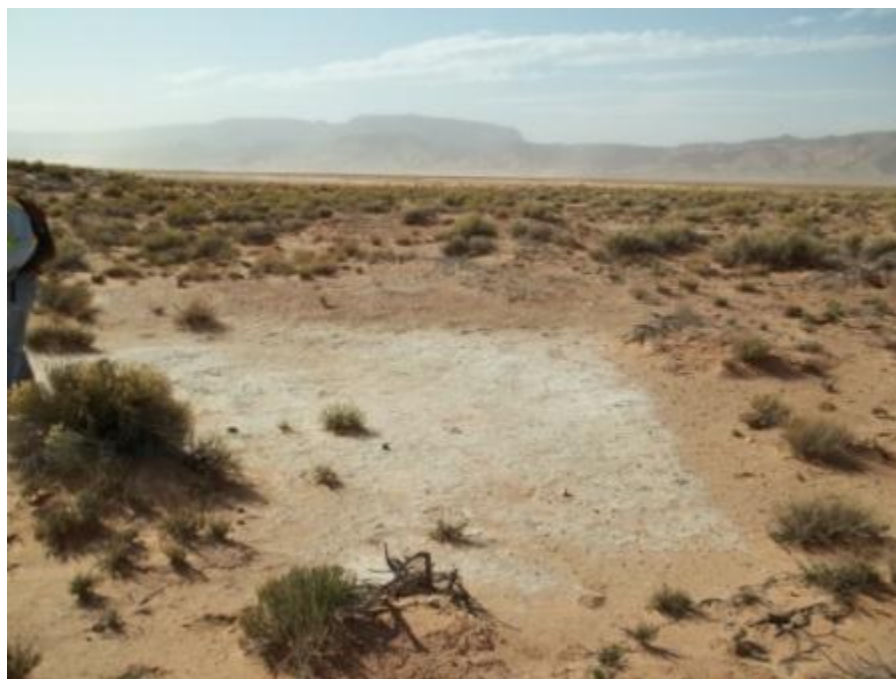
Photo 5

Mine Site #702 – Waste rock

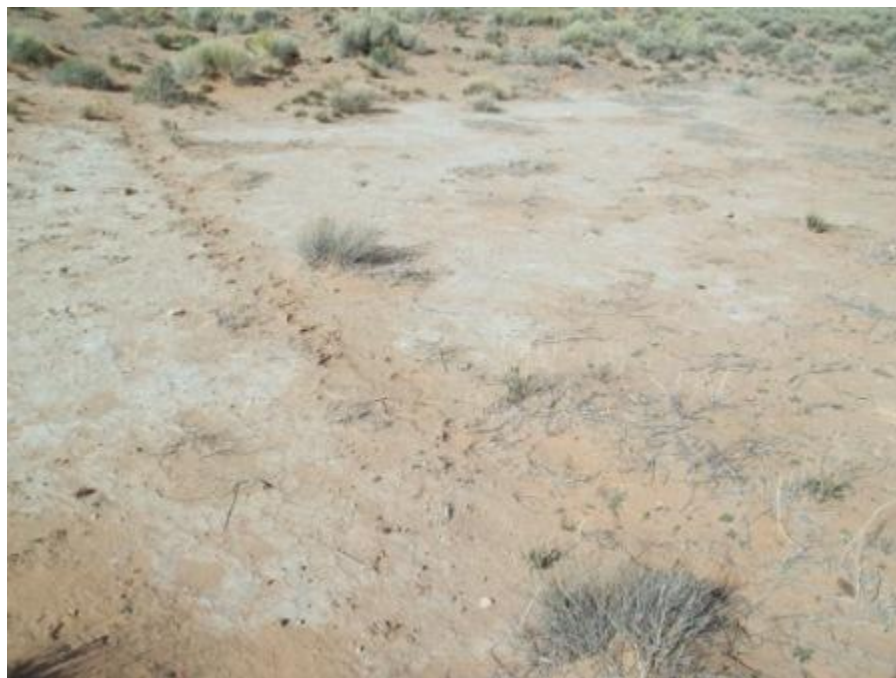
Photo 6

Mine Site #702 – Waste rock

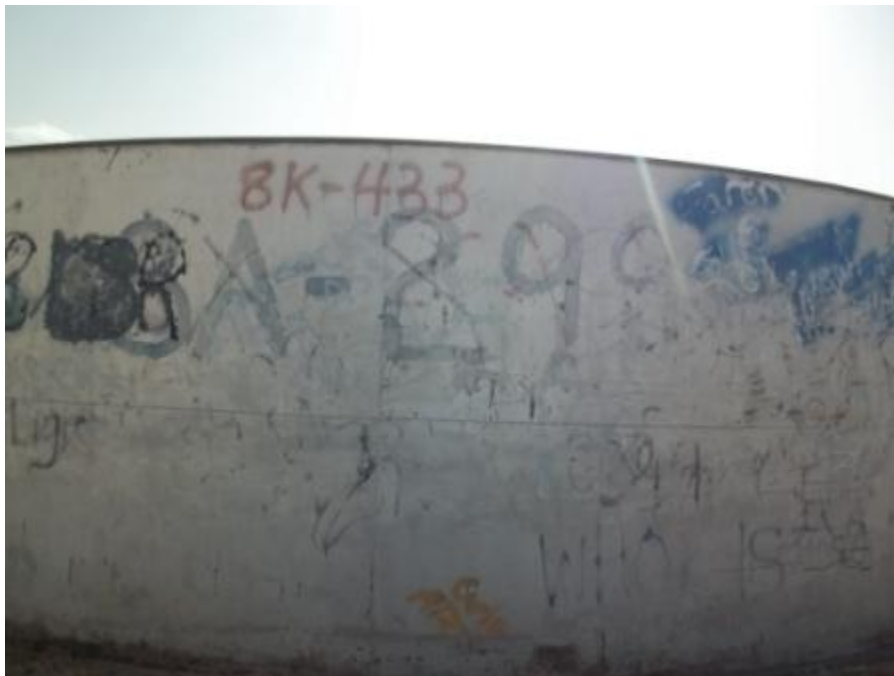
Photo 8

Mine Site #702 – Well 8K-433

0 to 0.25 miles: 750 ft NW - Water Well 8K-433
